UAV-based urban structural damage assessment using object-based image analysis and semantic reasoning

J. Fernandez Galarreta, N. Kerle, and M. Gerke

Faculty of Geo-Information Science and Earth Observation (ITC), University of Twente, Enschede, the Netherlands

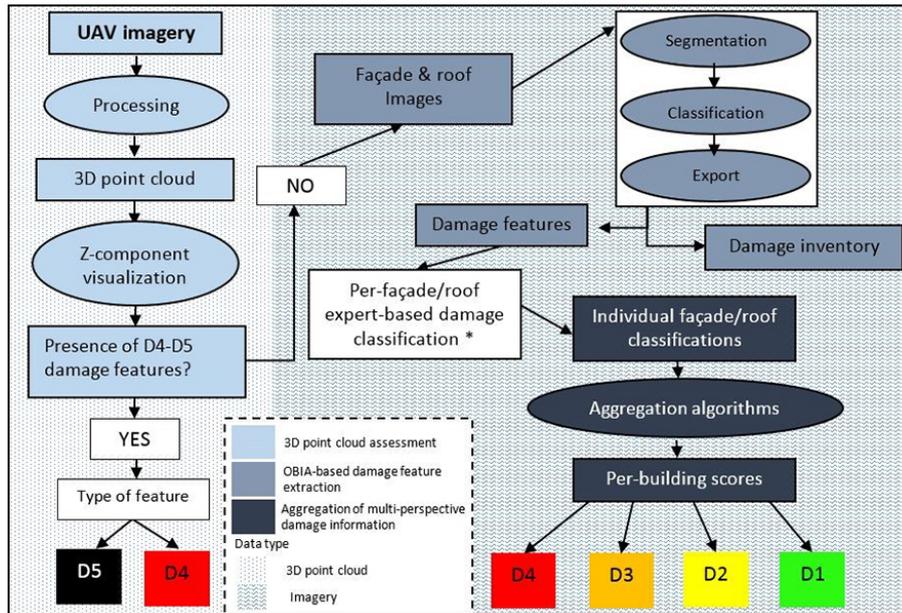
Figure 1. Overview of the methodology. * Fernandez Galarreta (2014).

This study aimed at generating per-building damage scores based on oblique, multi-perspective, highly overlapping and very high resolution imagery. Those were primarily acquired with a UAV, and partly with a camera attached to a pole, (details on image acquisition are given in Sect. 3.1). From the multi-view imagery, 3-D point clouds were generated to allow experts to visually identify the most affected building: D4–D5 (Sect. 3.2). Subsequently, the façade and roof images of the buildings that were still standing were analyzed with OBIA, where damage features were extracted (Sect. 3.3). In a separate experiment by Fernandez Galarreta (2014) the image data of buildings for which the 3-D point clouds did not reveal extensive damage, or the damage features were not visually identified, were subjected to expert assessment. Each image with overlaid information from the OBIA damage-feature extraction being assigned to an EMS-98 score and a certainty measurement. The process of aggregating the individual scores at building level, and thereby simulating the understanding of the expert surveyors on the ground, is described in detail in Sect. 3.4. Figure 1 provides an overview of the methodology.

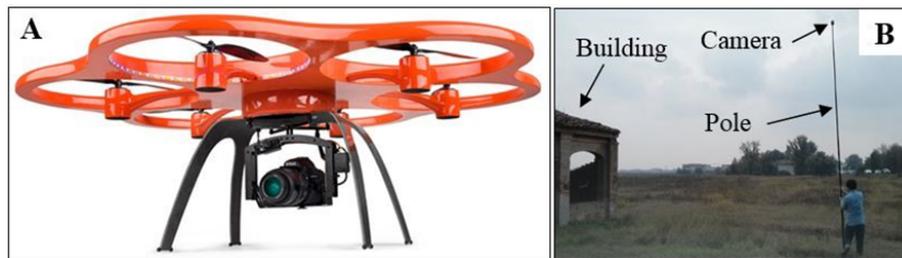
Figure 2. The two platforms used to collect data. (a) Aibot X6 V1 UAV, (b) camera attached to a pole.

The data for this study were collected with an Aibot X6 V.1 UAV (Fig. 2a), and with a camera attached to a 7 m pole (Fig. 2b). Several acquisition campaigns were made: Gronau (Germany), Enschede (The Netherlands) and several loca-

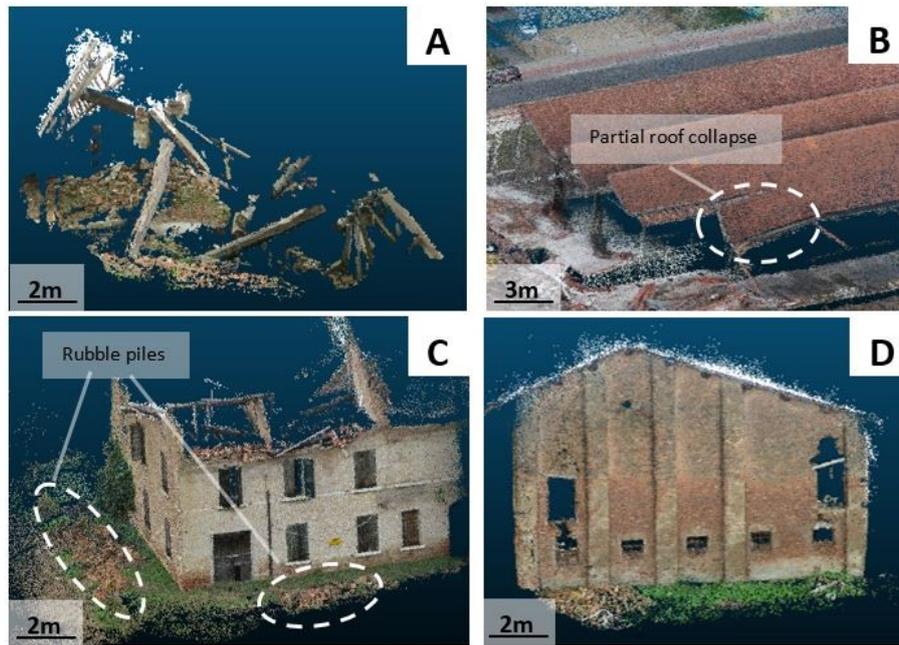
Figure 3. The 3-D point clouds used to identify the mentioned damage features. (a) Total collapse (Italy: pole-based), (b) partly collapsed roof (Germany: UAV-based), (c) rubble pile (Italy: pole-based), and (d) frontal view of an inclined wall (Italy: pole-based). Scale approx.

The test data set used to identify the damage features comprised four 3-D point clouds (Fig. 3) generated from the oblique overlapping images as explained below.

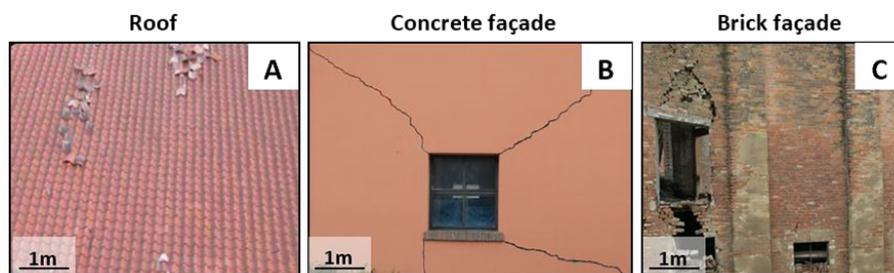
**Figure 4.** Examples of the different images used in this section. (a) Roof with dislocated tiles, (b) cracks in concrete façade, and (c) cracks and hole in brick façade. Scale approx.

The data set used in this section comprised 11 VHR images that represented roofs and two different types of façades: concrete and brick (Fig. 4). The selection of the images was done manually due to the complexity of the scenarios. For each of the three types, a rule set was created to extract the damage features.

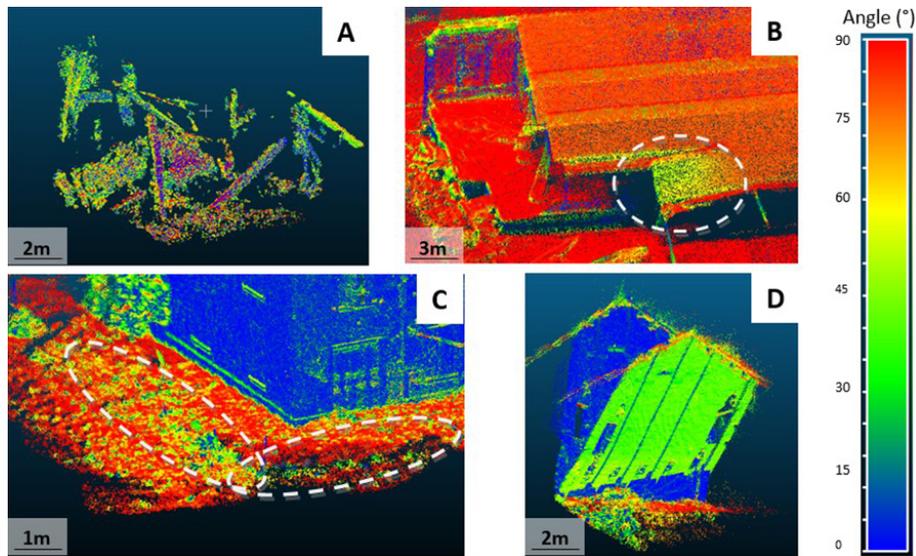
Figure 6. Z component visualization of target damage features: (a) collapsed building, (b) partially collapsed roof (outlined in white), (c) rubble pile (outlined in white), and (d) vertical façade (blue) compared to a simulated inclined façade (green). Scale approx.

The visual assessment of the 3-D point cloud’s *z* component allowed the identification of the previously listed damage features to classify a building as D4–D5 (total collapse, collapsed roof, rubble pile and inclined façade; Fig. 6).

We aimed at assessing whether a 3-D point cloud allows the identification of damage features indicative of D4 or D5 damage. Except for the identification of rubble piles (Fig. 6c) in situations where the grass around a building partially masked rubble presence, the results demonstrated that the visual assessment of the point cloud's z component was very useful to identify those damage features. In addition, it allows experts to identify subtle damage signatures, such as inclined walls (Fig. 6d), that are difficult to recognize in traditional BDA approaches. Nevertheless, the 3-D point-cloud assessment was not focused on the actual data processing and automatic analysis of the data sets, because of its expected complexity and novelty. Thus it focused on generating the 3-D point-clouds using existing approaches, before proceeding with a visual assessments of the data sets to identify the cited damage features.

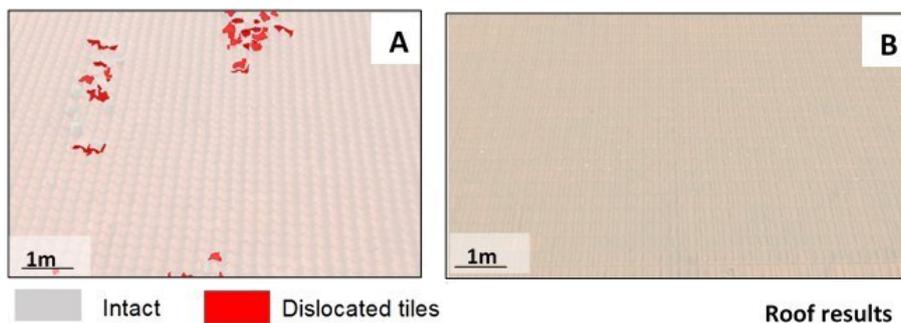
Figure 7. Result of applying the roof rule set on two roof images. Scale approx.

Accuracy parameter	Fig. 7a dislocated tiles	Fig. 7b intact façade	Fig. 8a Cracks	Fig. 8b Cracks	Fig. 8c Cracks	Fig. 8d Cracks
Correctness	66.6 %	100 %	65.7 %	25.9 %	87.2 %	84.8 %
Completeness	32.9 %	100 %	62.4 %	50.6 %	64.2 %	38.2 %
Accuracy parameter	Fig. 8b' Intact	Fig. 8c' Intact	Fig. 9a Cracks	Fig. 9b Cracks and holes	Fig. 9c Cracks and holes	
Correctness	100 %	100 %	57.0 %	53.6 %	72.4 %	
Completeness	100 %	100 %	45.5 %	79.1 %	89.8 %

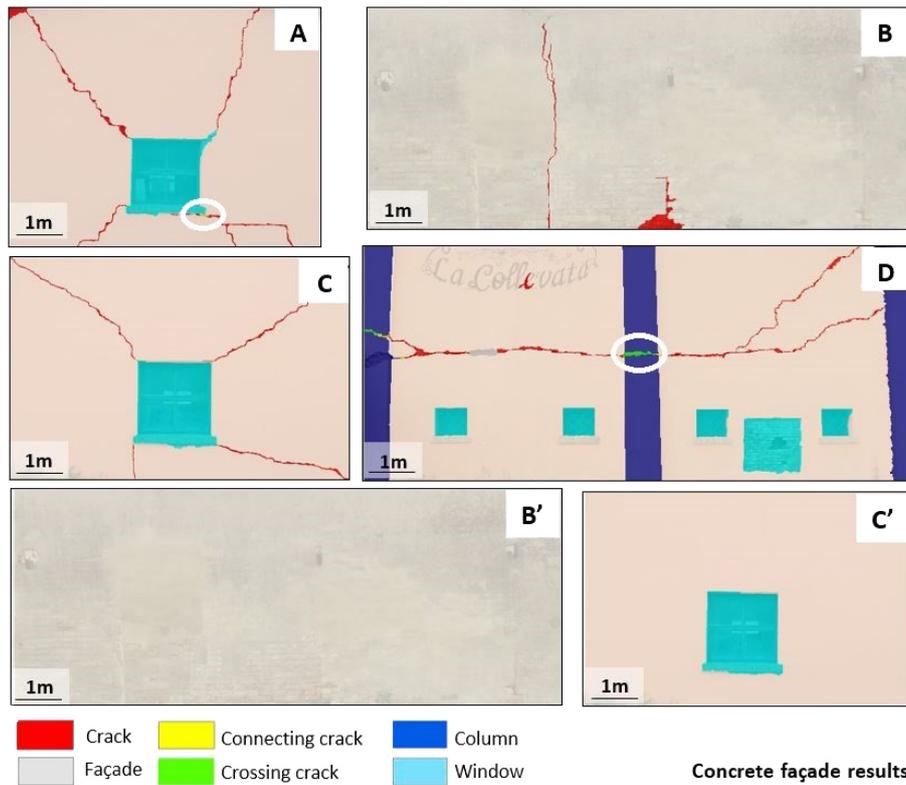
Figure 8. Results of applying the concrete rule set on six concrete façade. (b') and (c') were edited in order to remove the damage feature. (a) and (d) highlight cases of connecting and crossing cracks. (a) highlights with a circle the location of a connection, the small nature of a crack connecting with a window makes it hard to visualize it in the illustration. (d) illustrates a crack crossing a column as a green object (highlighted by circle). Scale approx.

The images shown in Fig. 8b and c were edited to remove visible damage features. The rule sets were re-run on those images to test their performance in a damage-free environment. The results are shown in Fig. 8b’ and c’.

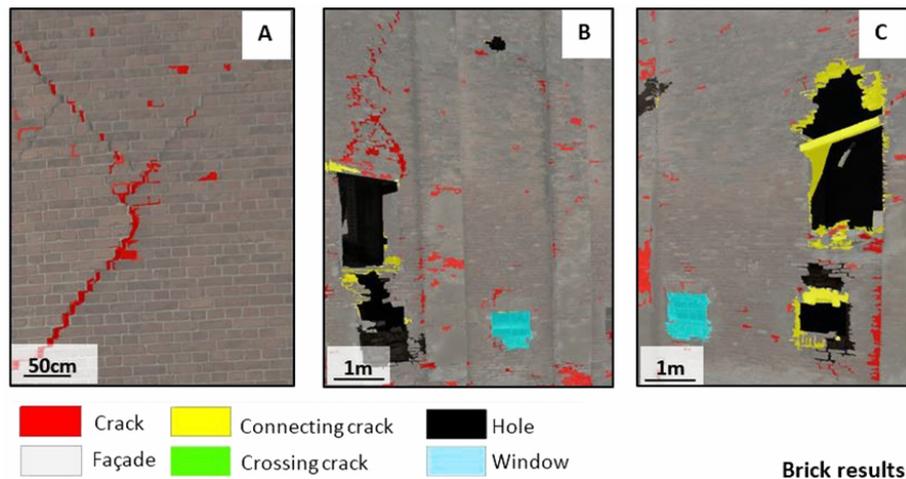
Figure 9. Results of applying the brick rule set on three brick façade images. Scale approx.

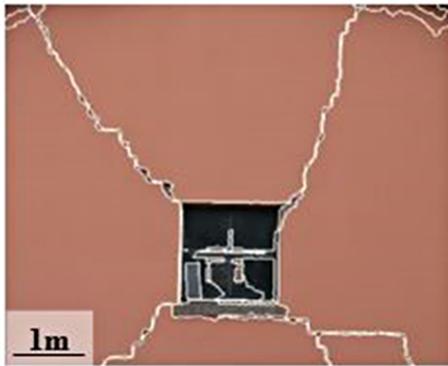
Figure 10. Result of the two-step segmentation of a concrete façade. Scale approx.

The two-step segmentation aimed at generating large homogeneous non-damage objects, whilst highlighting smaller damage features, and was largely successful throughout the different scenarios (e.g. Fig. 10). This set the theoretical approach for the OBIA-based damage-feature extraction.

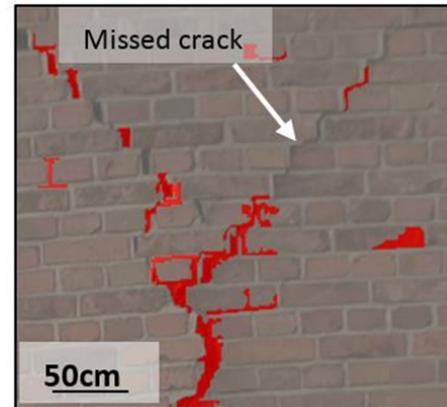
Figure 11. Example of misclassified crack due to segmentation problems. Scale approx.

(Fig. 11). Resulting segmentation errors propagated into the analysis stage, leading to misclassifications.

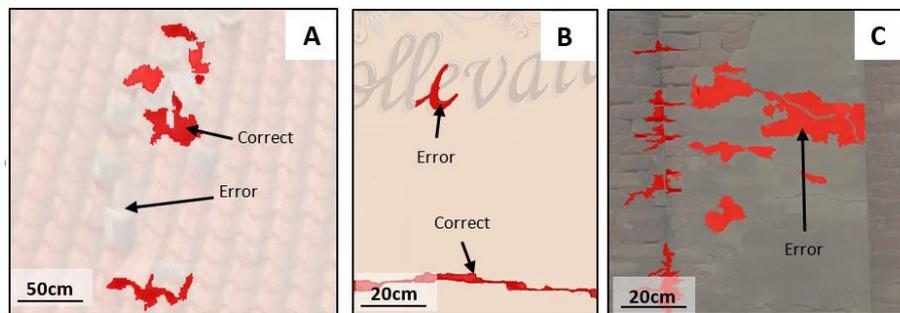
Figure 12. (a) Example of misclassified roof tiles (false negative), (b) example of a letter classified as a crack in a concrete façade (false positive), and (c) example of non-related objects classified as cracks in a brick façade (false positive). Scale approx.

The classification part of the rule sets had to deal with complex scenarios, many target damage features and a range of different images, leading to limited, but unavoidable errors. They included both false negatives (Fig. 12a) and false positives (Fig. 12b and c). This particular concentration of errors in the brick façades has to do with the actual pattern that the façade presents. The complex pattern presented in the brick façades challenges the segmentation algorithm that creates small non-damage related objects that during the classification process are mistakenly classified as cracks. Con-

Further, traditional accuracy assessment approaches do not address the semantic dimension of the extracted features. According to the feedback obtained after the expert-based per-façade / roof classification (Sect. 4.3.5 in Fernandez Galarreta, 2014) errors such as the one in Fig. 12b are flagged as FP, yet to an expert analyzing damage based on the OBIA

damage features this type of misclassification posed no problem. For the specific case of Fig. 12b, the expert knowledge allows an easy recognition of such an object as an artefact of the façade, a letter. It is directly understood as a non-damage related object despite its erroneous classification.

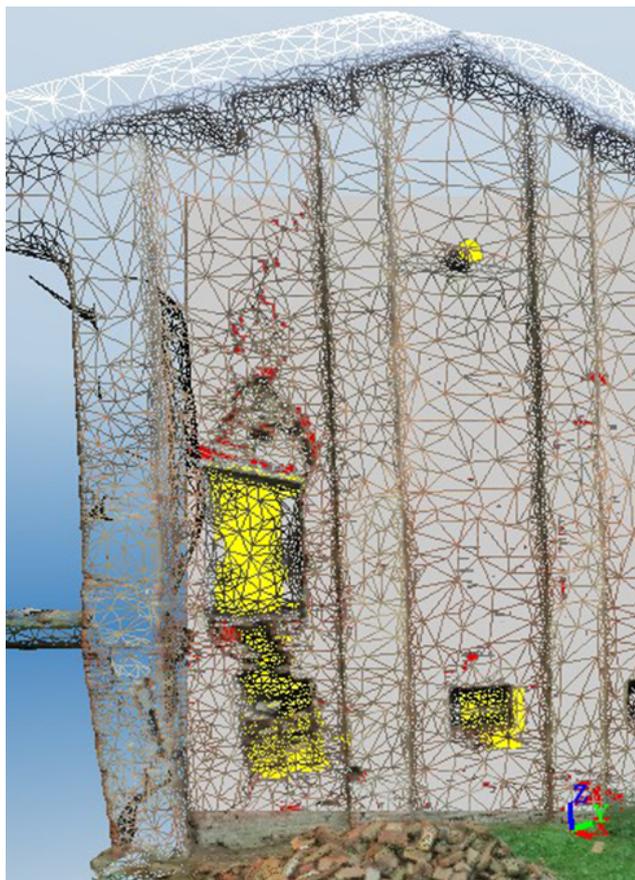
Figure 13. Example of the wire mesh with OBIA extracted information overlaid. Yellow indicated holes, and red indicated cracks in the façade (for better contrast, the color scheme was changed from the previous examples).
